REPAIR STRATEGIES OF A 10 STOREY OFFICE BUILDING

The present paper investigates the cracks that had developed in some of the floors and parapet walls soon after the construction of a 10-storied office building at Khulna in Bangladesh. The structural system of the building comprised of shear wall-frame interaction system. Two-way ribbed slabs were employed as roofs. The study attempts to identify the causes of the crack formation, the impacts of the cracks on the performance of the building and propose possible remedial measures. The slabs and the parapet walls had inadequate reinforcement. Ferrocement technology and other suitable methods were adopted for rectifying the design deficiencies.

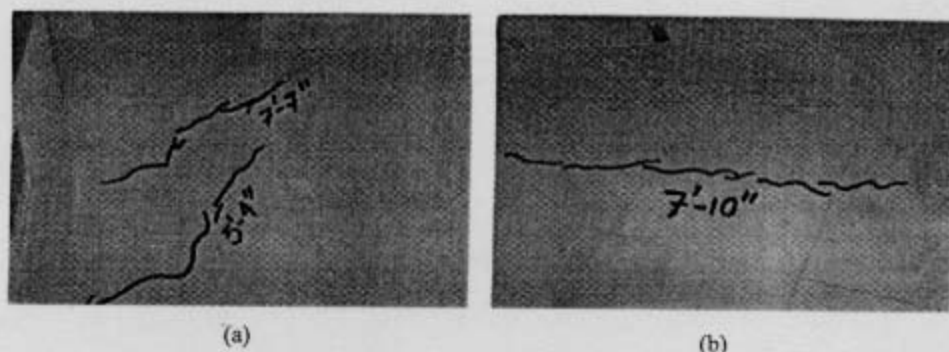
During the site visit it was observed that slabs of almost all the floors were cracked diagonally at most of the exterior corners. Horizontal cracks near the slab-wall interface were observed on the 4th and 6th floor. Figure 2a depicts typical diagonal cracks at the north-east corner of the slab of the 4th floor of the building. These 5'-4" (1625 mm) and 7'-7" (2311 mm) long cracks were about 0.15 mm wide. Similarly, Fig. 2b shows the typical horizontal crack at the North side of the slab of the 4th floor of the building. This crack in the figure is 7'-10" (2388 mm) long, about 0.12 mm wide and located at a distance of about 2'-5" (737 mm) from the wall. A detailed picture of the diagonal and horizontal cracks in the floor slabs can be obtained from Fig. 3, where crack positions in the 6th floor has been shown. Most of the cracks in the slabs had crack width ranging between 0.08 mm to 0.15 mm. Some of the diagonal cracks penetrated the whole depth of the top slab of the ribbed floors. Again, the parapet wall at the roof of the building contained major vertical cracks. These cracks extended from the bottom to the top of the wall. Figure 4 shows the approximate locations of such cracks with respect to the plan of the roof slab.

i) The first type of cracks observed were typical diagonal cracks at almost all the exterior corners of the floor slabs. From the design details it has been understood that all the exterior corners were devoid of any corner reinforcement. It is worth mentioning that corner reinforcements are necessary to prevent corner uplifts of the exterior corners. Absence of

appropriate amount of corner reinforcement is believed to be the primary cause of these diagonal cracks at the exterior corners.

Fig. 2 (a) Typical diagonal crack at the north-east corner and (b) typical horizontal crack at the north side of the slab in the fourth floor of the building

ii) The second type of cracks were observed on the 4th and 6th floor near the exterior wall and almost parallel to it. From the design details it was found that negative (top) reinforcement near the edge of the ribs supporting the slab was inadequate. Thus, the restraints near the edge supports of the ribs caused cracking parallel to the supports.

Calculate the number of cracked mosaic panels in each direction starting from the corner panel. Remove a square area of mosaic and mosaic bed (patent stone), each side of which will be equal to the length of the maximum number of cracked panels in either direction, plus the length of an extra panel and the distance between the wall edge and mosaic panels. Figure 5 shows the area of mosaic to be removed for repair of a typical diagonal crack at corner. Remove the mosaic bed carefully so that the structural slab beneath is completely exposed without much disturbance to it. The repair method is described below:

i) Scrub the exposed slab surface with steel brush; ii) Clean all dirt first by brushing with hand brush and then with a cloth duster; iii) Moisten the whole clean up area with potable water; iv) Place neat cement grout along the crack lines on the exposed slab. Grouting should not extend more than 75 mm on either side of cracks and should not be more than 2 mm thick; v) Ensure that the whole exposed area remains wet for about 12 hours after grouting; vi) About 12 hours after grouting, brush the exposed slab surface with neat cement slurry and quickly place 1 : 4 cement mortar mix over the exposed area trowelling it down to about 4 mm thickness; vii) Place 1.25 mm (20 Gauge) diameter galvanised wire mesh (12 mm x 12 mm size) covering the whole exposed surface. Place 8 mm diameter deformed bars (40 Grade) diagonally at a spacing of 100 mm centre to centre over the wire mesh laid diagonally as shown in Fig. 6; viii) Place micro-concrete mix (1 part cement : 2 part coarse sand (F. M. = 2.50-2.75) : 2 part small stone chips passing number 4 sieve) to cover the wire-mesh and diagonal rods placed earlier; ix) Place a second layer of wire mesh (having size and type same as given in step (vii) over the diagonal rods; x) Place 1 : 4 cement mortar over this wire mesh upto a thickness to bring up the existing mosaic bed level; xi) After 24 hours, lay the mosaic over this newly constructed reinforced bed.

i) Remove a rectangular area of mosaic and mosaic bed (patent stone) which will include area between the wall edge and the mosaic panels, all the cracked panels and an extra panel adjacent to every cracked panel. ii) All other steps are exactly the same as described for corner crack repair except that the 8 mm deformed bars at a spacing of 100 mm centre-to-centre between two layers of wire mesh are to be aligned perpendicular to wall face (see Fig. 7).

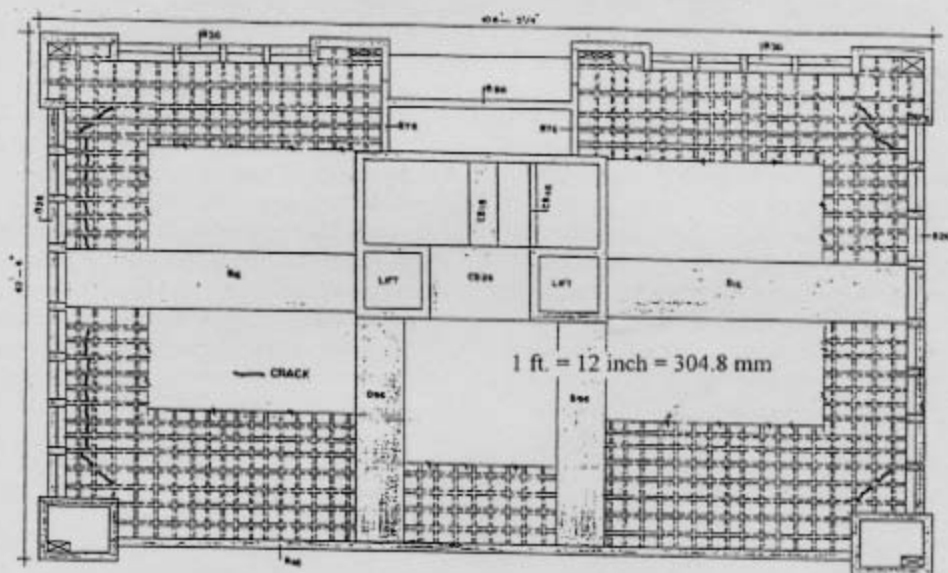
Fig. 3 Crack location in the 6th floor of the building

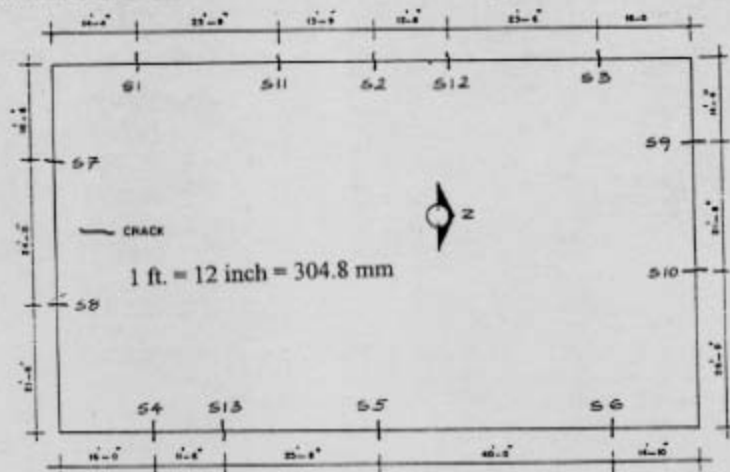
iii) The third type of cracks were the vertical cracks of the parapet wall at different locations. It has been observed that the longitudinal reinforcement provided in the parapet wall of the roof

was less than what has been prescribed as nominal temperature and shrinkage reinforcement in ACI Building Code 318-89 [1]. Considering the warm weather condition in Bangladesh and the fact that the parapet wall remains exposed to sunlight all day long, the amount of longitudinal reinforcement should have been even more than what has been prescribed in ACI Building Code.

Fig. 4 Location of cracks in the parapet wall

Method II: Provide expansion gaps at the parapet wall crack locations marked S1 through S10 in Fig. 4. This can be achieved by first chipping off the concrete from both sides of the crack, making an opening of about 50 to 60 mm. All the horizontal bars (binders) shall be saw cut from both ends and the pieces removed. Then carefully plaster the ends with 1 : 6 mortar mix to bring the final gap width down to about 20 mm. At the bottom of the opening, provide an inward slope so that rain water drains into the roof surface.

The cracks marked S11, S12 and S13 in Fig. 4 may be repaired by stripping 20 mm of plaster or concrete up to 300 mm on either side of the crack and then by wrapping this exposed surface of the wall with one layer of 18 gauge (1.4 mm diameter) 12 mm x 12 mm grid wire mesh. The mesh has to be covered with non-shrink micro-concrete (1 : 2 : 2) following the description given in Method I. Apply the decorative wall finishing to all the repaired areas in the parapet.
