Effect of Flood on Earth Structures: A Case Study

M. A. Ansary and A. M. M. Safiullah

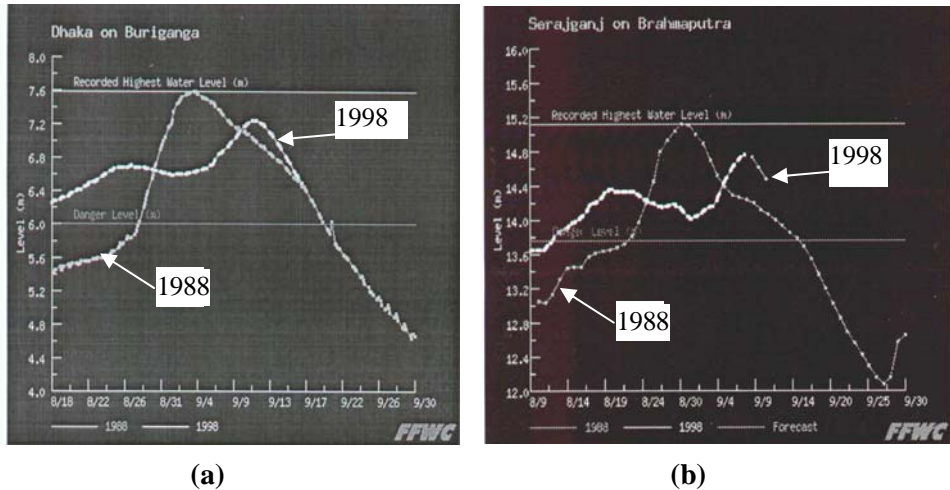
Figure 1: Flood hydrographs of (a) Buriganga River at Dhaka and (b) Brahmaputra River at Sirajanj, during the 1988 and 1998 floods

Figures 1 shows hydrographs of 1988 and 1998 floods for river Buriganga at Dhaka and Brahmaputra-Jamuna at Serajgonj. In 1998, the river

stage at the Hardinge Bridge point exceeded all its previous records. It can be observed from the hydrographs that although flood stage for 1988 flood was higher at most places, duration of water level above danger mark was much longer during the 1998 flood.

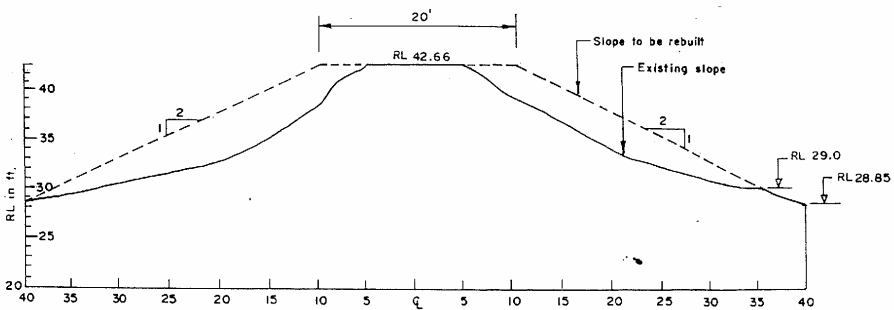
Figure 4: Typical cross-sectional profile of railway embankments in Ishurdi-Sirajganj route

Figure 4 shows typical cross-section of railway embankment in Ishurdi-Sirajgonj route after the 1998 flood. The section shows considerable erosion of the existing slope. From an analysis of the available cross-section, it was noted that most of the damage occurred above RL. 30 ft (railway datum). There was no evidence of scour at the toe of the embankment suggesting that the instability of the embankment was mainly associated with high water level and wave action. Protection measures to protect slopes against wave erosion may be taken to slopes lying above RL.30 ft.

The general strategy for preventing damage to embankment during flood is to provide appropriately designed revetment to cover the embankment slope within the portion vulnerable to wave attack. In addition to wind-generated waves, waves may also be generated from boats navigating close to the embankment and this should be considered in designing the revetment work. Within the Railway embankment areas visited, no evidence of deep sliding was observed. At some locations longitudinal cracks at the top of the embankment were noted which appeared to have resulted from instability due to loss of soil from toe and mid portion of the embankment slope. There was evidence of very little scour near the embankment borrow pit areas. From Fig. 4, it is apparent that originally the embankment had a uniform side slope of 1 (Vertical): 2 (Horizontal), which was considerably modified by the process of removal of soil by erosion, particularly within the zone of waves action. The present slope shown in Fig. 4 reflects typical S-shaped profile usually generated by wave action on a slope.

At one location revetment system with aggregate filter and cement concrete (CC) blocks was installed by the Railway. The protective system appeared to be quite effective against wave attack during the 1998 flood. But at some points damage to revetment system was noticed due to loss of soil underneath aggregate filter resulting in subsidence of the CC blocks. Therefore adoption of a design similar to that already used may be considered adequate, provided provision is made to prevent migration of soil particles from underneath the CC blocks. Use of a geotextile layer may serve this purpose (Safiullah and Ansary, 2000).
