Assessment of Flood Damage to Roads in and around Dhaka City and Remedial Measures

Moazzem Hossain, Alamgir M. Hoque and M. Zakaria

Department of Civil Engineering

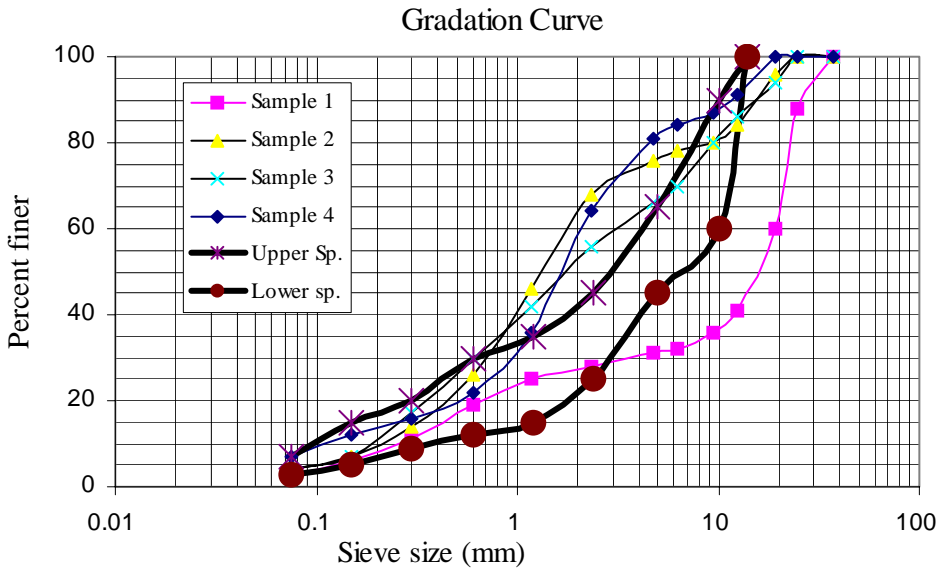
Figure 1: Comparison of aggregate sample gradation with the suggested (RHD, 1994) gradation range

From bitumen extraction it has been found that two out of four aggregates samples are shingles and rest two are stone chips. The gradation curves of all the four aggregate samples along with the suggested (RHD, 1994) gradation range have been plotted in Figure 1. It is suggested (RHD, 1994) that aggregates used should consist of chipping with a maximum size 8 to 14 mm. Thus, from Fig. 1 it can be observed that none of the samples, especially the coarser portion of the aggregate, are within the specified range. The results of AIV tests on base/sub-base aggregates are presented in Table 4. Aggregate gradation has a significant influence on the overall stability and strength of the asphalt concrete mix. From
