Impact of the 1998 Flood on the Morphology of Rivers around Bridges

**M. Mozzammel Hoque, Sujit K. Bala, Syed Mohib Uddin Ahmed,
M. Anisul Haque and Saifullah Al Mamun**

Institute of Water and Flood Management

Abstract

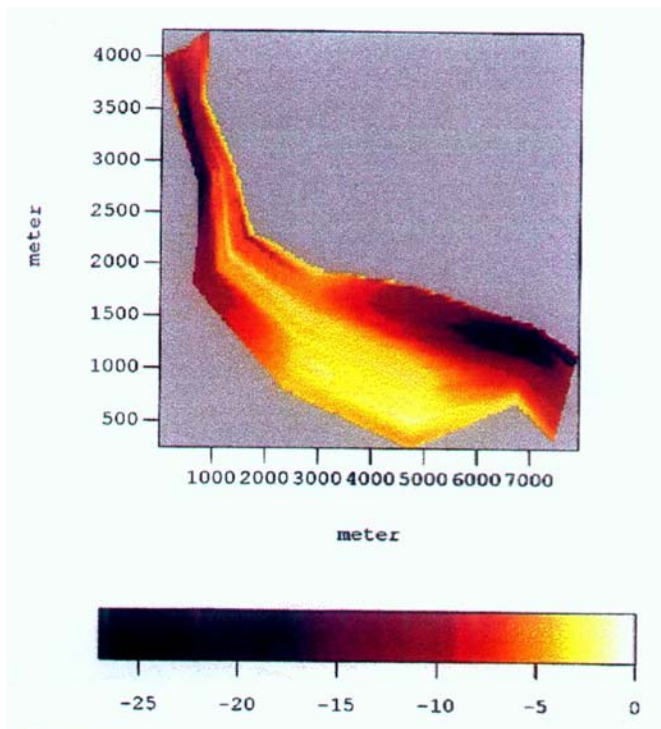
Figure 3: River bed during May 1998 (before the 1998 flood)

At section from L_{10} to R_{10} , significant erosions have taken place on the left side showing depth around 20m near the bank. A comparison of Fig. 3 and Fig. 4 reveals that at right bank some deposition has taken place during the 1998 floods. Downstream to this section on the right bank, the highest color shows further deposition where the depth is close to only 5m. However, further downstream to this section at the middle of the river where a sand bar existed before, significant erosion has taken place on the right side of the sand bar and the depth has reached to about 20m. This erosion has extended up to a reach of about 2km. On the left side of this section (left bank) further deposition has taken place. Further downstream up to the bridge and to the end of the reach, both sides show no change between the pre-flood and post-flood conditions. In general a significant change was found to have occurred in the bed level of the river Meghna upstream of the bridge during the flood of 1998.

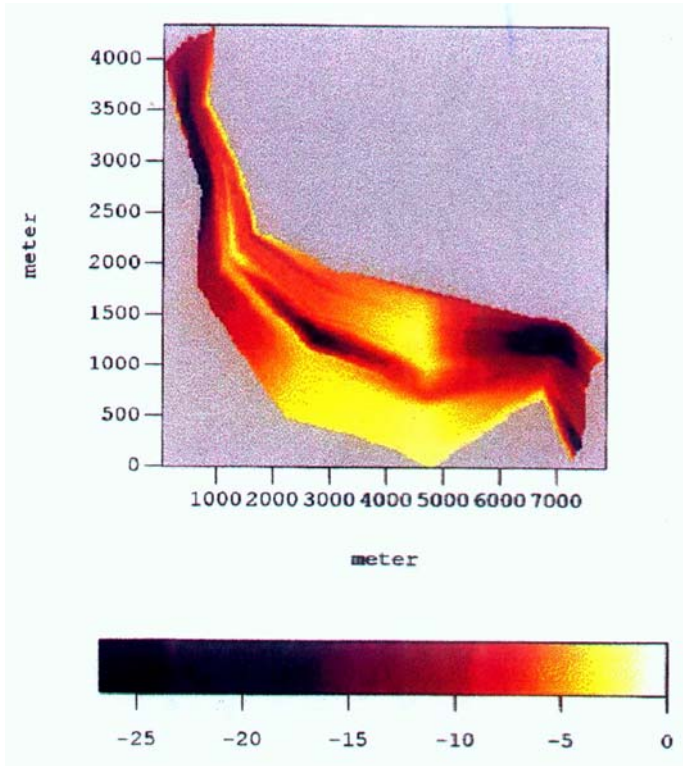
Figure 4: River bed during October 1998 (after the 1998 flood)

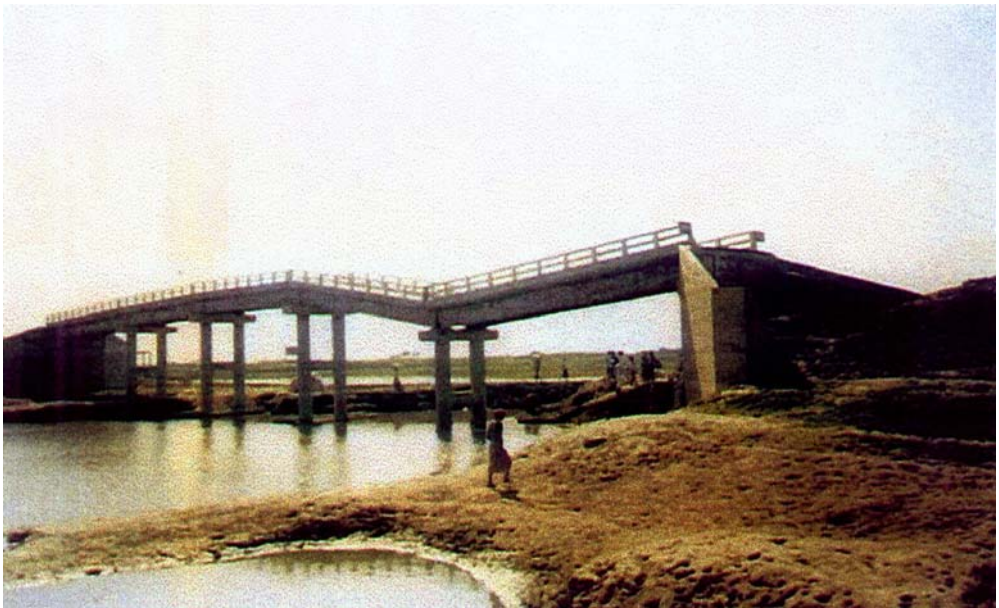
Figure 5: Settlement of Pier-1 of Turag-Bhakurta bridge on Turag-Bhakurta road near Amin Bazar close to Dhaka-Aricha road during the 1995 flood (Date: 25-02-95)

Design elevation of pile end at bed of the bridge was (-) 6.75m. It is evident from Fig. 7 that scour depth at pier-1 during the 1995 flood reached almost the pile length. Maximum scour was about (-) 6.60m below bed elevation. As a result, the pier got settled down from the effect of load of deck slab and girder. But during the 1998 flood, scour depth reached the extent of about two times the pile length of the bridge. Maximum scour is about (-) 13.40m below bed elevation (Fig. 7). Hence, total bridge had been washed away except for the portion of the bridge rehabilitated after the 1995 flood. The pile length provided for the rehabilitated pier is about 30m. During the 1995 flood the outflow discharge at the damaged bridge section was about 1047 m³/s. During the 1998 flood the outflow discharge at bridge section was about 1370 m³/s. As a result, enormous pressure was exerted on the structure. For the passage of the discharge of the 1995 and the 1998 floods through the bridge section, the adequate opening length should have been 154m and 176m, respectively. But the bridge length is only 67m. Hence, due to enormous thrust of floodwater heavy morphological change occurred during flood period. The failure of the bridge is mainly due to a severe morphological change. Flood level in 1998 was 9.70m and the bridge was partially submerged. So, enormous hydraulic pressure was exerted on the bridge during the flood of 1998. As a result, the bridge was washed away.

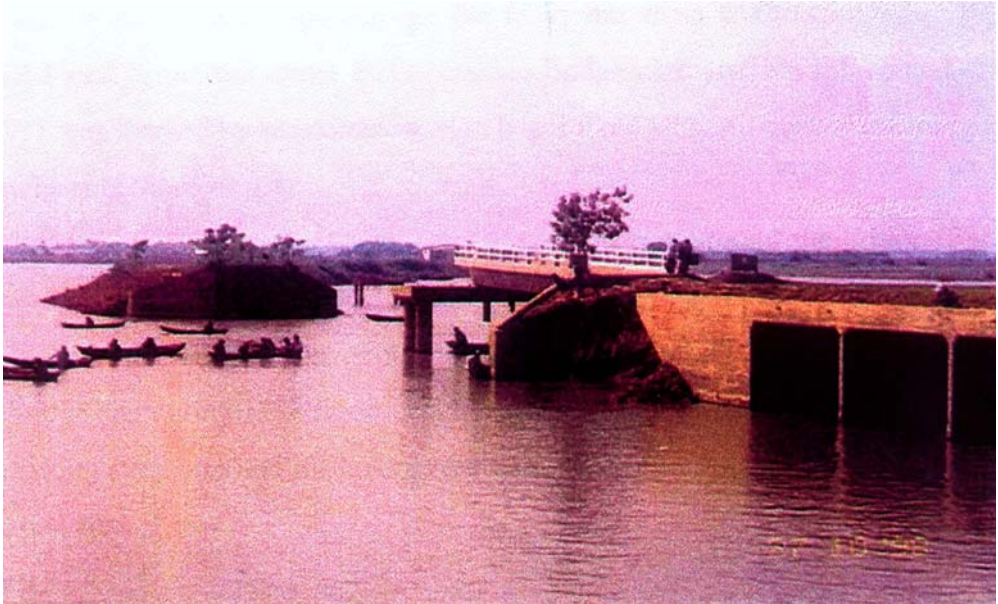
Dhaka. The bridge connects a number of villages e.g., Bhakurta, Kamrangirchar, and Keranigonj with Dhaka. The construction of the bridge together with other structures on Turag-Bhakurta road has made communication easy towards capital Dhaka for the people of these areas especially during rainy season. The bridge consists of 5 spans with length 67m each and width 3.70m. After the construction of the bridge, about 1km portion of Turag-Bhakurta road was raised and upgraded. The raised portion of the road used to go under water every year during flood and floodwater flowed freely over it during flood season. Following the rise of road level, the bridge came under heavy water pressure during the 1995 and 1998 floods due to obstruction of free flow of floodwater. During 1995 flood, the first pier of the bridge from Dhaka-Aricha side settled down by about 1.61 m (as seen in Fig. 5). After recession of flood, the bridge was rehabilitated by providing additional piles with length of up to 30m at the affected pier. During the 1998 flood the bridge again came under flood attack and was washed away except for the pier rehabilitated after the 1995 flood (as seen in Fig. 6).

Figure 6: Washed away Turag-Bhakartha bridge on Turag-Bhakartha road near Amin Bazar close to Dhaka-Aricha road at Savar during the 1998 flood (Date: 27-10-98)

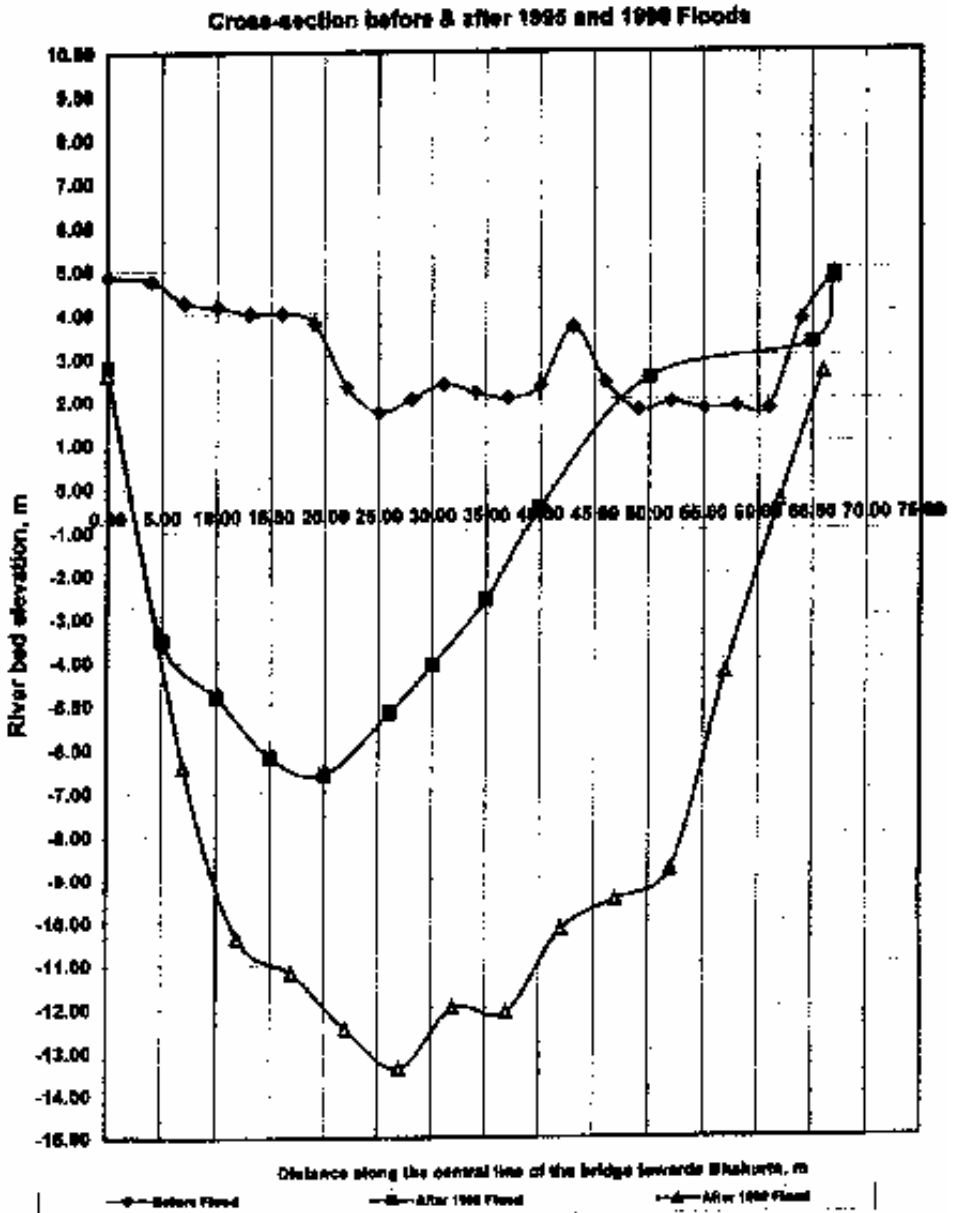
Discharge at damaged bridge section during the 1995 flood was about 1047 m³/s while during the 1998 flood it was about 1370 m³/s. For the passage of 1995 flood discharge through damaged bridge section, opening length should have been about 154m. But actual length of ridge was 67m. Hence, substantial morphological changes or scour had occurred at affected bridge section during the 1995 flood reaching a scour depth of (-) 6.60m as shown in Figure 7. For the passage of discharge through the bridge section during the 1998 flood, opening length should be about 176m. So significant morphological changes had occurred during the 1998 flood reaching a scour depth of (-) 13.40m as shown in Fig. 7. As a result, the bridge was washed away.

Figure 7: Cross-section at damaged bridge section before and after the 1995 and 1998 floods
