COLLAPSE OF AN UNDER-CONSTRUCTION TEXTILE FACTORY BUILDING

The paper presents the results of an investigation concerning the failure of a segment of an under-construction reinforced concrete roof of a textile factory building which had collapsed during casting. When the collapse of the roof took place, concreting of an area of about 1700 m², out of a total of 3586 m² area of the segment, was completed and steel binding and formwork construction of the whole segment was almost done. The segment of roof slab that collapsed was 68.4 m long in the East-West direction with a downward slope of 1%. The failure of the roof was followed by collapse of the formwork of other areas where concreting work was not taking place. Consequently, all the 74 columns and most of the footings of the whole segment also underwent damage. Although the reinforcement bindings of the inverted beams were complete at the time of casting the slabs, none of the inverted beams were cast during the period when slab casting was in progress. This resulted in the casting of a vast area of slab resting on poor quality bamboo props. Casting of inverted beams after completion of respective slab casting would have added t

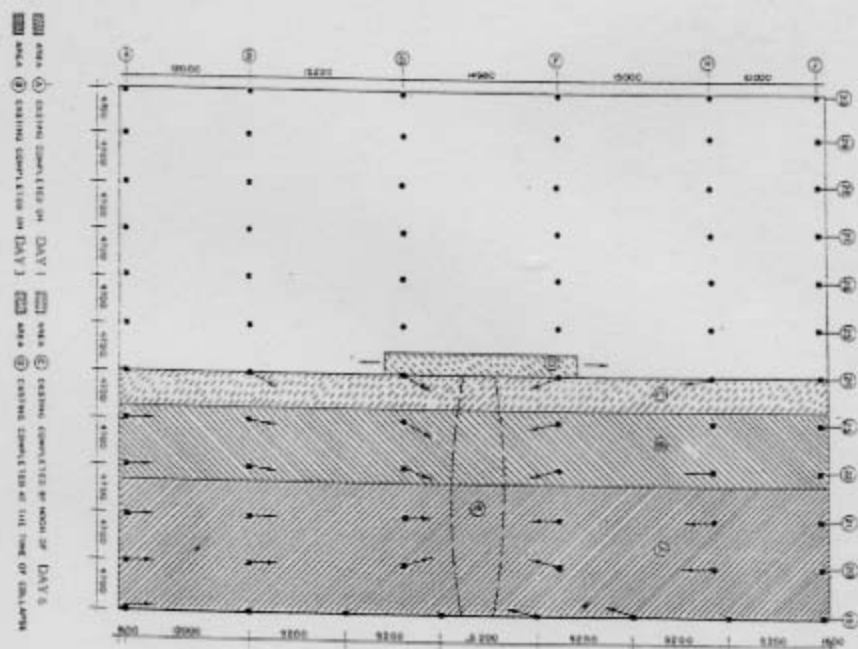
A part plan of the Spinning Department consisting of the collapsed segment of the textile factory is shown in Fig. 1. This consists of columns spaced at 4.7 m spacing in the North-South direction and at 9.2 to 15.22 m spacing in the East-West direction allowing large free areas for the proposed use. On day 1 and day 3, the casting of the roof of Spinning Department between rows 19 and 23 was completed (Fig. 1). Then on day 6 the casting of roof slab resumed from row 23 and by noon that day it was completed upto the 24th row. While the casting operation was in progress in the afternoon and was within halfway between row 24 and 25, all on a sudden all the

concreting work done so far from day 1 to the afternoon of day 6 collapsed with a terrible sound and most of the roof was on the ground in no time. Figure 1 also shows the area E (shown cross-hatched) towards which the collapse ultimately propagated with respect to the part plan of the factory building where construction work was taking place from day 1. The arrows show approximately the inclination of the columns after failure. While Fig. 2a shows the overall condition of the working site 3 days after collapse, Figs. 2b, 2c and 2d give a closer view of the collapsed construction where casting took place on the day of collapse, 3-5 days earlier and where formwork as well as reinforcement binding was completed on the day of collapse. It is to be noted here that during the collapse of the roof, all the adjoining columns also sustained damage. This happened due to the fact that at the time of collapse steel binding of other portions of the roof, where concreting was not taking place, and all the inverted beams was almost complete. Figure 3 shows such a portion of the roof where reinforcement of roof slab and inverted beams attached to the columns can be seen. It is apparent from the figure that after the failure of the formwork even in the regions where concreting was not taking place, columns were overstressed by the hanging reinforcement of the slab and beams resulting in the damage of the columns and some footings. Whereas the structural design as well as structural system of the textile factory building was also checked, albeit in less detail, the formwork was studied in great detail from its design to erection in an effort to primarily determine the cause of the collapse of the factory building, as failure took place at a time when structural elements were not supposed to carry loads [1].

Fig. 1. Part plan of the factory building showing the collapsed area

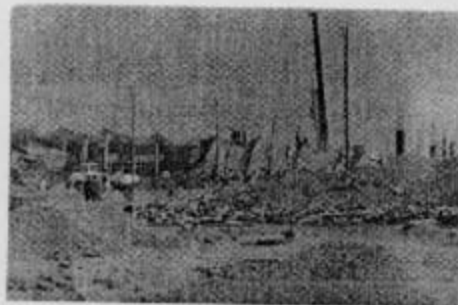
Fig. 2 (a) General view of the collapsed construction site, (b) collapsed roof where casting took place on the day of collapse, (c) collapsed roof where casting had taken place earlier, and (d) collapsed roof where formwork and reinforcement binding was completed on the day of collapse

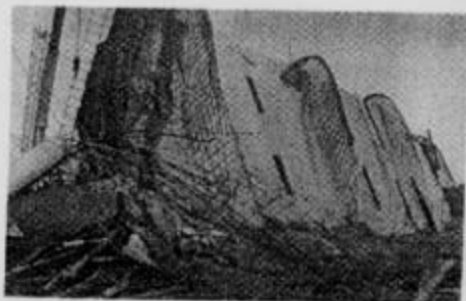
(c)

The conditions of structural elements, such as slabs, beams, columns and footings, etc. were assessed. The structural elements around the collapsed area as well as in other adjoining areas were surveyed. Damaged columns in and around the collapsed area (Figs. 4a and 4b), movement of footing beneath collapsed column (Fig. 4c), improper casting sequence of inverted roof beams (Fig. 2c), and roof slab with closely situated top and bottom bars (Fig. 5) were noticed.

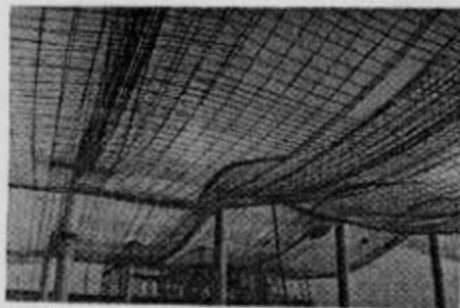
Fig. 3 Reinforcement of roof slab as well as inverted beams being held by cracked columns after the collapse of under construction roof slab in the adjoining areas

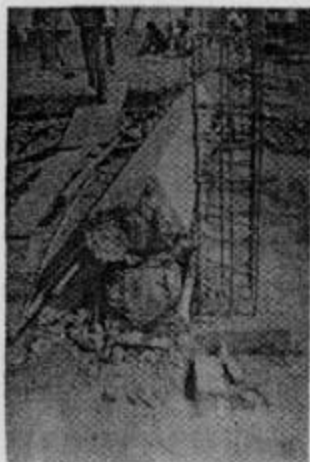
Fig. 4 (a) Damaged square column, (b) damaged circular column, and (c) movement of footing beneath collapsed column.

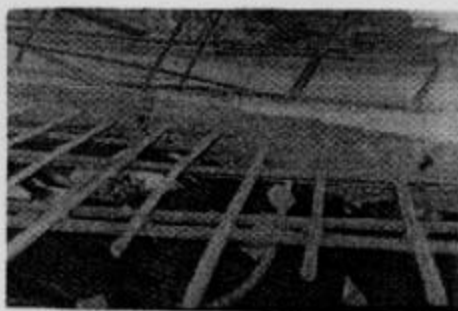
Fig. 5 Part of the collapsed roof slab showing closely spaced top and bottom bars in the slab

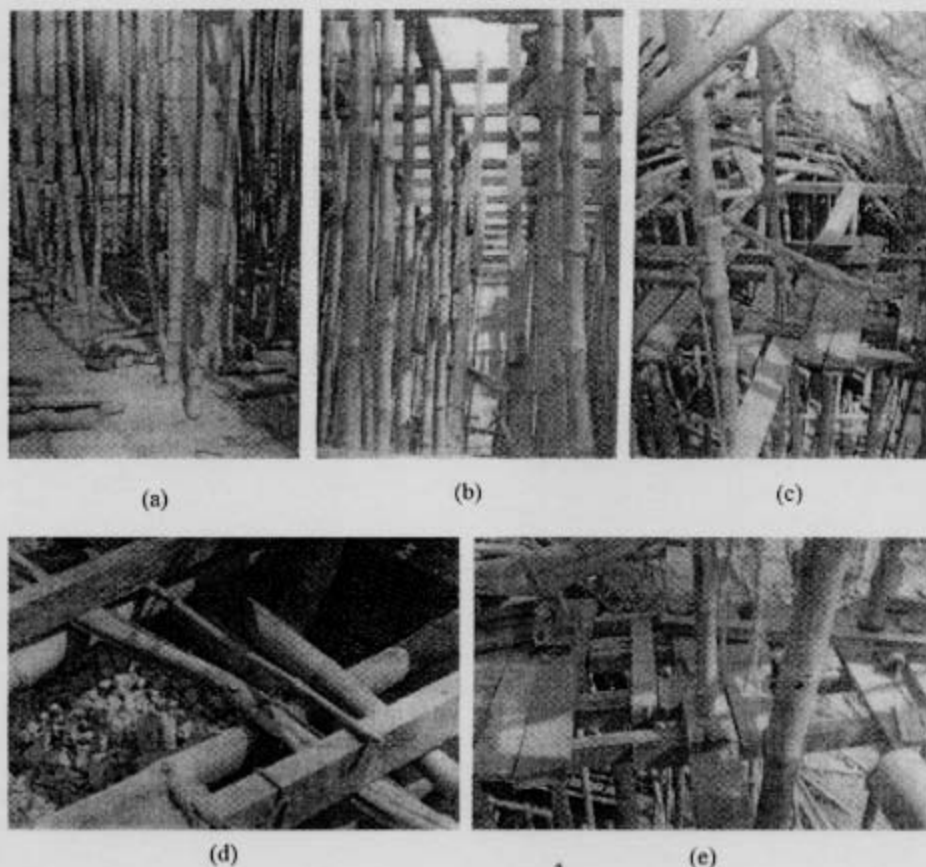
The "formwork" used for construction of the roof consisted of a two-stage fabrication made of bamboo props and wooden rafters and planks, supporting a concrete "form" with plain mild steel sheet base. The bamboo poles used as props of the lower stage were placed generally over pieces of wooden plank laid on the ground or directly on the ground. These bamboo poles supported a grillage consisting of wooden rafters in one direction and planks in the other. In general the overall quality of the formwork materials, specially the bamboo poles used as props, was poor. There were undersized, crooked and out of vertical poles as was evident from the existing scaffolding work near the collapsed segment. Figure 6 presents a general view of the scaffolding arrangement and quality of work.

The 5.79 m to 6.48 m high propping work made of crooked and slant bamboo poles, broken in the middle by the lower staging, had no lateral diagonal bracing. The so-called lateral bracing placed horizontally was not only grossly undersized (see Fig. 6d), but also they were placed, in case of bottom stage of the work, at about one-third height from the bottom instead of

Fig. 6 (a) View of narrow as well as crooked haphazardly arranged bamboo props used in scaffolding, (b) general trend of using low quality material as props by the Contractor (bamboo props have been replaced by pieces of wooden planks put together by nails - the ensuing strength and verticality of such make-shift props is questionable), (c) upper stage bamboo props resting on the junction of a pair of planks, (d) extremely small diameter members used as bracing, (e) levelling wedges made from bamboo/timber

Any future construction work of the factory building should be preceded by a satisfactory design of formwork. It should be well braced diagonally as well as horizontally and should be capable of resisting, in addition to vertical loads, the other effects that introduce lateral force components or introduce displacement of support members. Adequate provisions should be kept to prevent rotation of edge beam forms running in the East-West direction, where slabs frame into them on one side only. Form watchers in adequate numbers should be on the job during concreting. A system of formwork filled with wet concrete has its weight at the top and is not basically a very stable structure. Usually, good practice in designing and constructing formwork, and in handling and using it, can provide safety as well as efficiency. During casting, adequate care must be taken in an effort to ensure that at the time of concreting operation reinforcing bars are not displaced from position. Travel time for the green concrete from the mixing plant to the place of casting should be kept to a minimum. The sequence of construction as well as structural system should be worked out early in accordance with the type of design employed for the structure. The sequence must not invite instability or reduce stability at any stage during construction.
