Evaluation of Performance of Rajshahi Town Protection Embankment

**Abu Siddique, Md. Hossain Ali, Md. Shariful Islam
and Md. Monwarul Islam**

Abstract

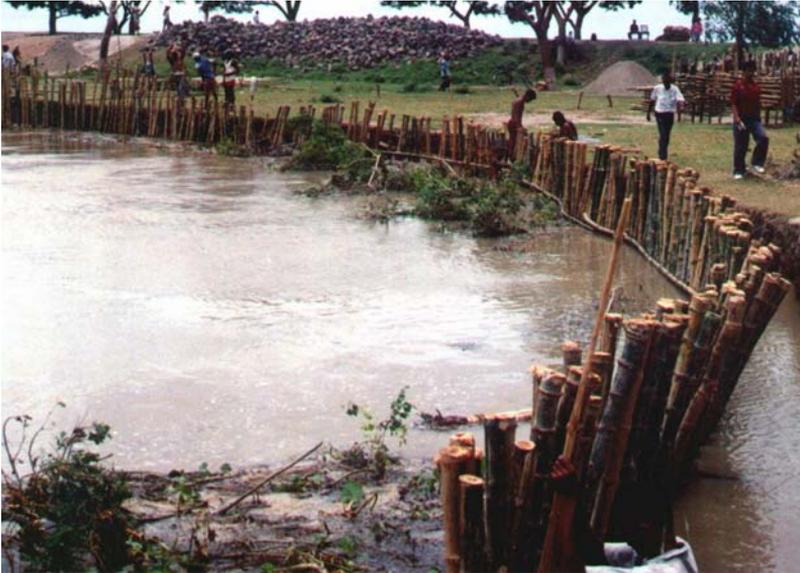
Figure 1: Photograph showing bamboo piling for erosion protection

Several types of protective works were undertaken for the protection of the embankment from erosion due to flood. Photographs of various protective measures are shown in Figs. 1 to 3. The following protective works were undertaken: (i) Bamboo Piling: Extensive bamboo piling was carried out for the

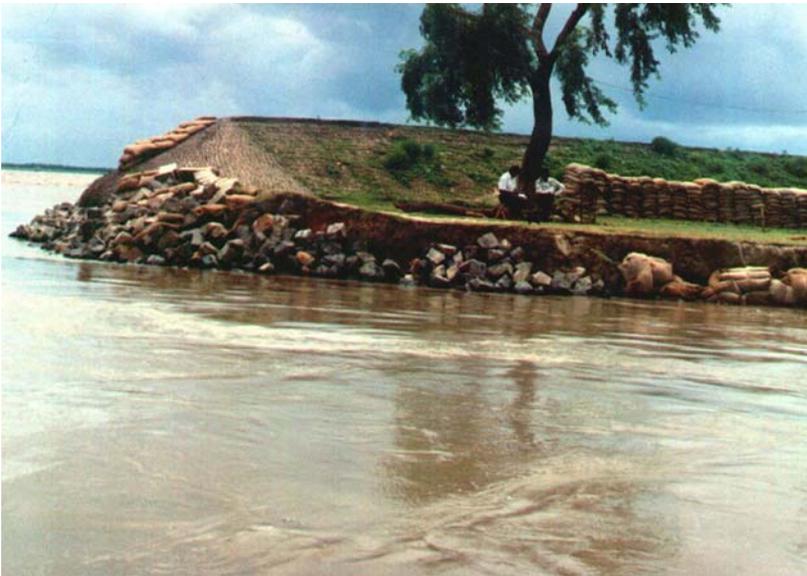
Figure 2: Photograph showing dumped rock boulders on groyne of the embankment

protection of embankment against erosion; (ii) Dumping of Boulders: Boulders were dumped on the upstream and downstream of groynes and closure for their protection; (iii) Dumping of Sand Bags: Gunny bags filled with local sand were dumped in order to prevent seepage, erosion of groynes, spurs and closure. Approximately 1,35,000 sand bags were dumped, of which 85000 bags were dumped at the T-Groyne; (iv) Percupine: This is a method in which bricks were encased in bamboo boxes. These boxed were placed at the locations where boulders and sand were found to be washed away; (v) Brick Crates: Bricks were placed in a netted wire and placed on embankment slopes for their protection; (vi) Dumping of Brick Bats: Gunny bags filled with brick bats were dumped at several places of the embankment for erosion protection; (vii) Polythene Cover: This was used to prevent erosion due to rain cut. The whole embankment (from upstream toe to the downstream toe) was covered with polythene when heavy rainfall took place. A total of 1200 m polythene cover having width of 30 ft was used.

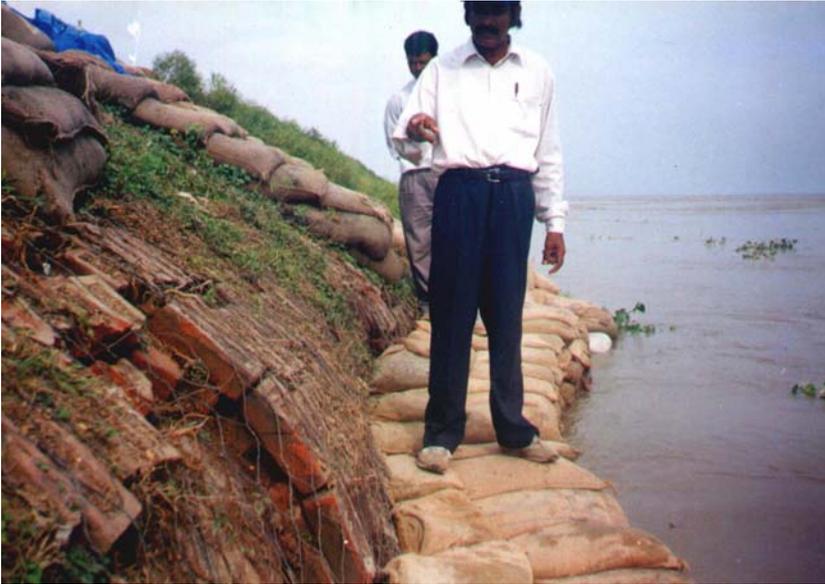
Figure 3: Photograph showing dumped sand bags and brick crates on the embankment slope

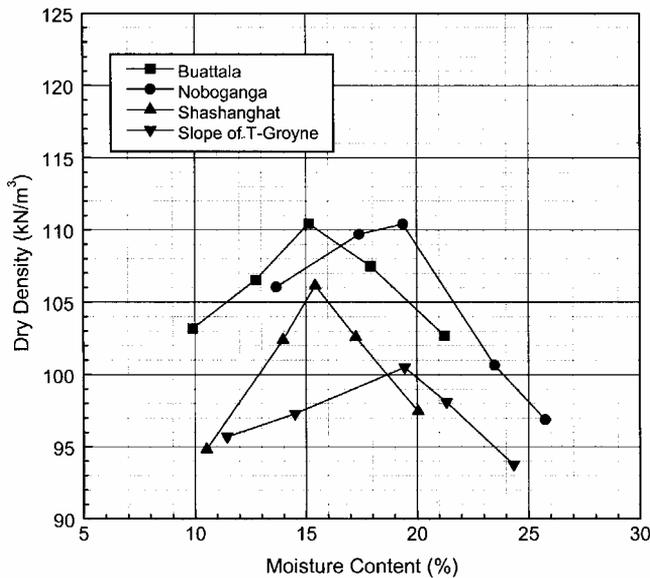
Moisture-density relationships were determined for four samples obtained from four selected locations of the embankment, namely, slope of T-groyne, Buattala, Noboganga and Shashanghat. Each test was carried out following the procedure outlined in ASTM D698 (ASTM, 1989). The moisture-density relations of the four samples are presented in Fig. 4. From the moisture-density curves, optimum moisture content (w_{opt}) and the corresponding maximum dry density for the soil samples were estimated. The values of the w_{opt} and maximum dry density of the

samples varied from 15.1 % to 19.5 % and 100.5 lb/ft³ to 110.4 lb/ft³, respectively. In-place density of the embankment soil was determined at ten spots of the above-mentioned four locations of the embankment, following Sand Cone Method. A summary of the field density test results is shown in Table 2. It can be seen from Table 2 that the *in-situ* dry density and compaction of the soil samples at four locations of the embankment varied from 84.3 lb/ft³ to 105.1 lb/ft³ and 79.5 % to 95.2 %, respectively. The average value of the degree of field compaction at the ten spots was found to be 85.3 %. Although the embankment suffered significant erosion and that the embankment soils were not compacted after the floodwater had receded, an average compaction of 85.3 % indicates that the embankment soils are still in a state of fairly good degree of compaction.

Figure 4: Moisture-density relations of selected embankment soil samples

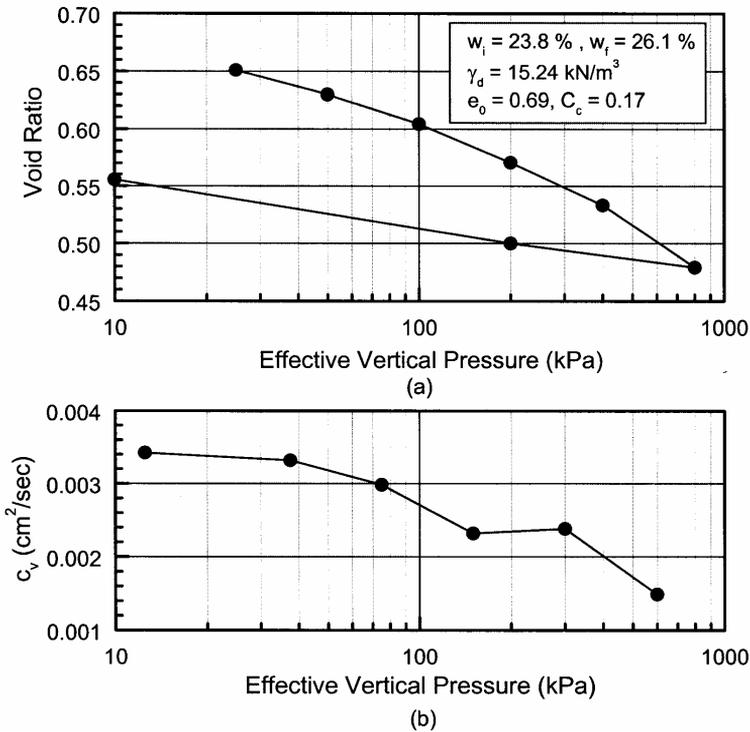
logarithmic of pressure curve shown in Fig. 5, was found to be 0.17. The initial void ratio (e_0) of the sample was found to be 0.69. Low values of C_c and e_0 indicate that the compressibility of the sample is low. Depending on the stress range, the values of coefficient of consolidation and coefficient of volume compressibility of the soil sample have been found to be in the range of 1.49×10^{-3} to 3.71×10^{-3} cm^2/sec and 0.88×10^{-4} to 9.8×10^{-4} m^2/kN , respectively.

Figure 5: Compressibility plots of a sample: (a) void ratio versus log of effective vertical pressure, (b) c_v versus log of effective vertical pressure

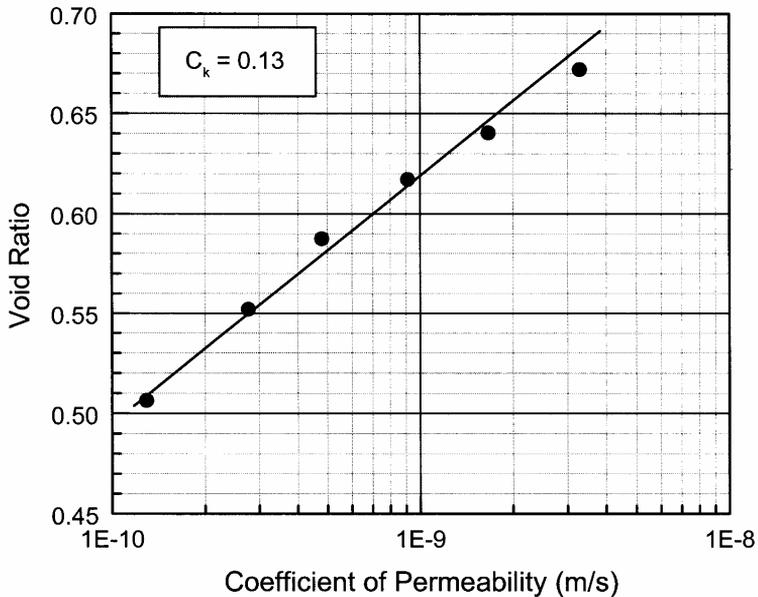
Coefficient of permeability of the samples was determined indirectly from one-dimensional consolidation tests. Depending on the void ratio, the values of coefficient of permeability of the soil samples varied from 1.29×10^{-10} m/sec to 3.29×10^{-9} m/sec . Void ratio versus logarithm of coefficient of permeability plot has been presented in Fig. 6. It can be seen from Fig. 6 that, the relationship between void ratio and permeability is approximately linear. The average slope of the relationship, which is termed the permeability change index (Tavenas et. al., 1983), C_k for this sample is 0.13. The ratio of compression index to permeability change index, i.e., C_c/C_k for the sample is 1.3. Berry and Wilkinson (1969) reported

Figure 6: Void ratio versus coefficient of permeability plot for a sample
