DISASTER MANAGEMENT IN METROPOLITAN DHAKA

Salek M. Seraj

Bangladesh University of Engineering and Technology
Dhaka, Bangladesh

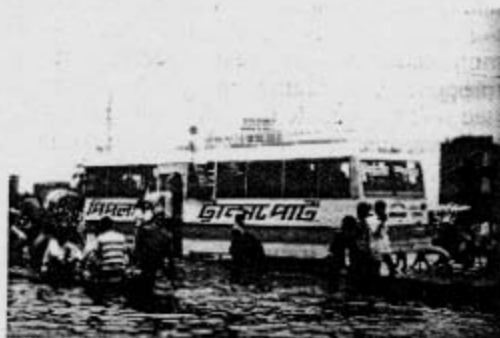
Figure 1. Water-logged Dhaka City Roads after Rains

The capital city of Dhaka is virtually submerged underwater in almost all places whenever rains drench the city for some time. The city's outworn and ill-planned sewerage system fails to cope with the discharge at every occasion. As a result of the water-logging, traffic at some major city intersections move with great difficulty while many cars and other vehicles are stalled after getting stuck in water-logged roads. The grave condition that prevails frequently in Dhaka city roads can be visualized from figure 1 where even boats can be seen competing with rickshaws and buses. The situation turns worse at the time of floods.

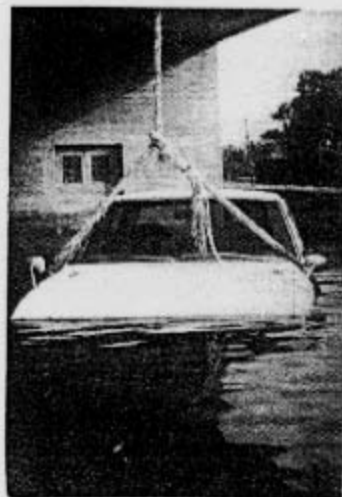
Figure 2. Scene from the 1988 Flood in Dhaka City

During the monsoons of 1987 and 1988, Bangladesh suffered two of the most serious floods on record. During these floods, vast areas of Dhaka, with a huge population of about 4.8 million people, were inundated to a phenomenal degree with flood levels at about 150 cm above normal for periods upto four weeks. It is estimated that about 200 km² of the total 260 km² area of Dhaka City was submerged to depths ranging between 30 to over 450 cm and flood damages exceeded Taka 700 million (US\$17.5 million). About 60 per cent of the city's population was directly affected by these floods. Figure 2 shows the desperate bid of a Dhaka dweller to save his car from the onrush of flood water during the flood of 1988.

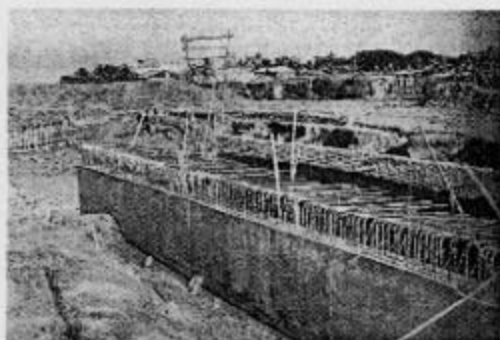
Figure 3. Under-construction Reinforced Concrete Storm Sewerage Box Culvert in Filled Land

At present, the whole city is devoid of any storm water drainage system. Consequently, water is collected in roads, ditches and low-lying areas. In an effort to save the capital from the evils of flood, a gigantic project was started after the flood of 1988. Under *Flood Action Plan (FAP)*, *Dhaka Integrated Flood Protection (FAP-8B)* was formulated. In practice, apparently, *FAP-8B* has turned out to be one of the causes of water-logging problems of the capital. The primary objective of the project was to construct embankments and flood walls along the perimeter of the city. The work was to be complemented by the provision of pipe sluices, cleaning and repair of internal drainage canals, and improvement of sewerage system.

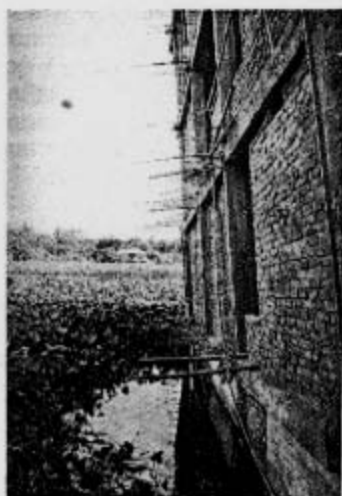
Figure 4. A Multistorey Building after Failure of Foundation due to Unregulated Design

its jurisdiction are safe from the structural design point of view. In August 1993, an under-construction framed structure collapsed at Mahakhali just half an hour after the last bucket of concrete was poured onto the roof of its third floor. The structure was being constructed in a water filled low-lying area without proper consideration given to the properties of the underlying soil. The foundation of the building settled on an average of about 300 cm (see figure 4) with a tilt of about 10 degrees towards the eastern side of the building.

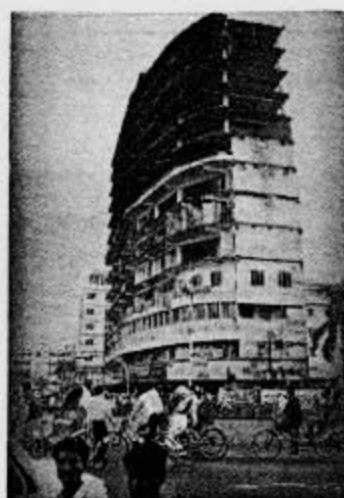
Figure 5. A 13-storey Framed Structure Stands at Heart of City without Occupants
It required the concerned authorities quite some time before discovering design faults and stopping construction and occupancy to avert possible disasters.

A number of serious accidents have occurred in Dhaka City as an outcome of the prevailing confusion in the design arena. In 1985, in a Dhaka University residential hall, thirty-three students died and forty-three others were injured when the worn out roof of a more than seventy-year old auditorium collapsed. There are many such old buildings specially in the older part of Dhaka City. If immediate steps are not taken for their repair and rehabilitation, many of those old and other newly constructed but badly designed structures may collapse even at a tremor of low magnitude, during heavy rainfall or floods. Among many other poorly designed buildings, Faridpur Mansion in the Kakrail area (shown in figure 5) is one. The upward expansion of this building at the heart of the city went unabated until thirteen storeys were constructed. The ineffectiveness of the enforcing agencies is clear from this incident. The infill walls of the top floors were stripped off and occupation on these levels were stopped. A court order prevents the concerned organizations from demolishing this unauthorized and structurally unsafe building which poses a hazard to everyone in the vicinity of the structure.
