Assessment of Water Quality in Flood Affected Areas of Dhaka City

Md. Mujibur Rahman, Md. Mafizur Rahman and Md. Delwar Hossain

Department of Civil Engineering

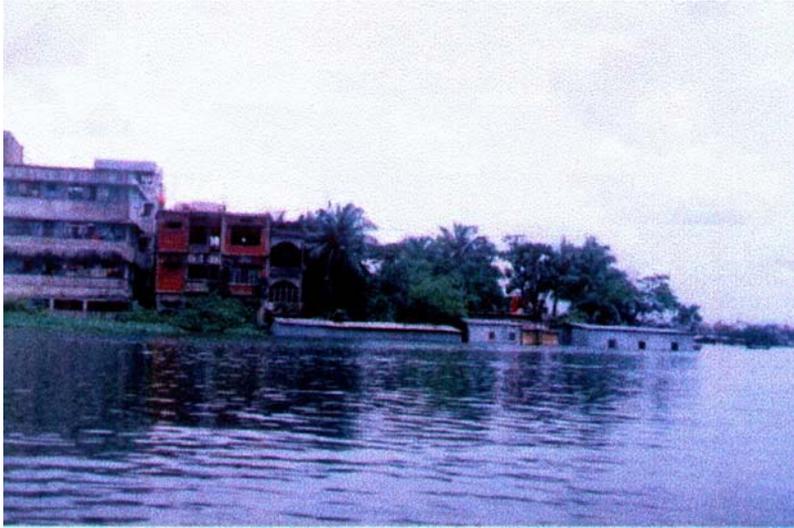
Figure 2: (a) The eastern part of Dhaka city during the 1998 flood, (b) Small boats plying on the roads in a flood-affected area

The long duration of the 1998 flood caused immense sufferings of the people in the affected areas. Disruptions of drinking water supply, sanitation, waste disposal, and disease transmission were among the major adverse impacts of the 1998 flood. This flood heavily affected the eastern part of the capital city, Dhaka. The residents of this part of the city suffered the consequences of this devastating flood. Embankments constructed after the devastation of 1988 flood however, protected the western part of the city. Most of the houses and roads in the eastern Dhaka were inundated by the floodwater (see Fig.2). The water supply system, the sewerage system, gas pipe network, underground electric and telephone cable system all remained submerged for the entire duration of the flood. About three million people in the affected areas of Dhaka got marooned. People had no other option but to use the manually driven small boats that replaced all the motorized and non-motorized vehicles on road.

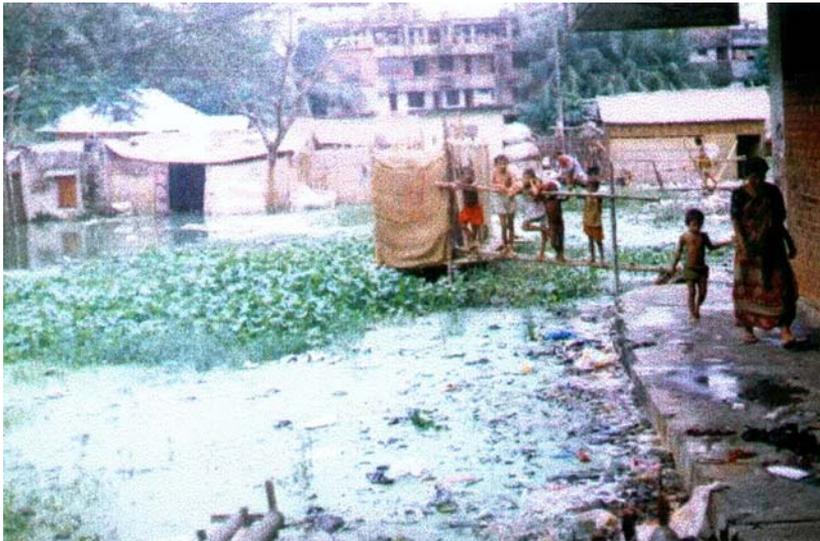
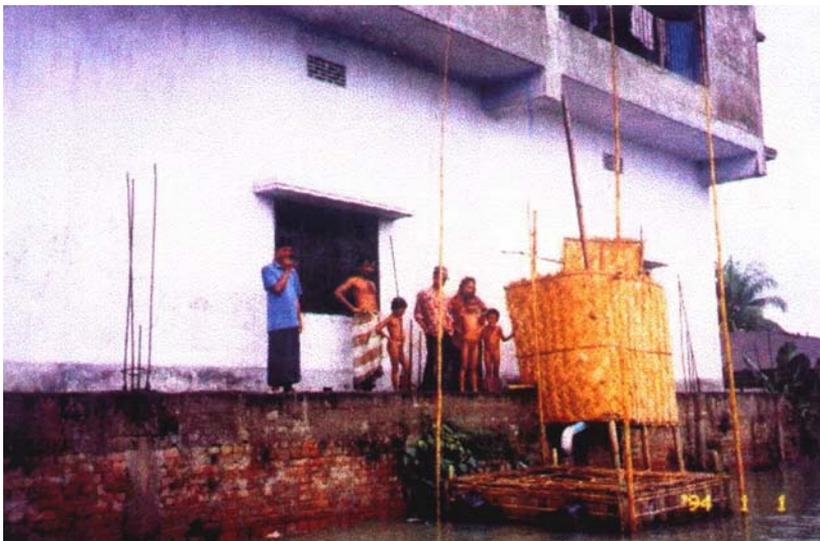
Figure 2: (c) Status of sanitation and solid waste disposal around residences in a flood-affected area, (d) Direct defecation in a flood-hit area
