Effect of the 1998 Flood on Non-Engineered Structures

Salek M. Seraj and Md. Rezaul Karim

Department of Civil Engineering

Bangladesh University of Engineering and Technology, Dhaka-1000, Bangladesh

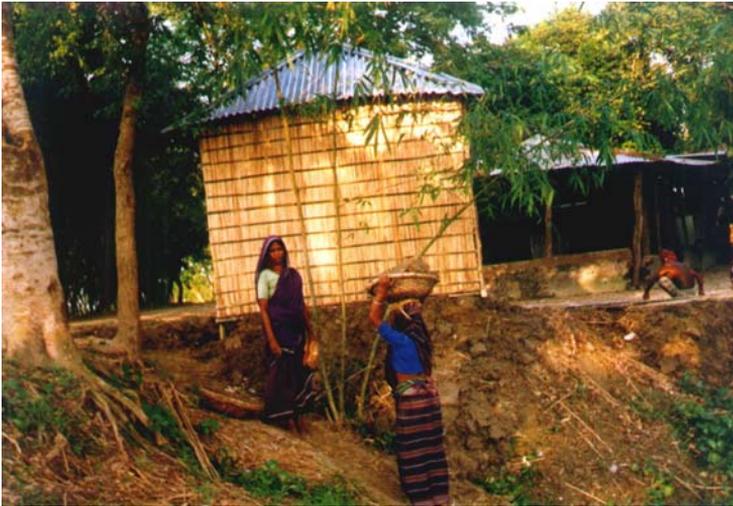
Figure 2: A *kancha* house

Various types of houses that exists in the study areas were critically inspected to quantify the state of the houses. In all study areas, most of the houses were *Kancha* (Figure 2). Some semi-*Pacca* (Figure 3) and *Pacca* (Figure 4) houses were also found. *Kancha* is the type of house in which the building materials are mainly bamboo, G. I. sheet, wood, G. I. Wire, rope etc. The *Vitte* of the *Kancha* houses is made of compacted earth. The pillars are made of bamboo. Again, semi-*Pacca* is the type of house in which the building materials are mainly bamboo, G. I. sheet, wood, G. I. Wire, rope etc. The *Vitte* of this type of house is made of compacted earth or sand, with a 10 inch brick wall boundary around it.

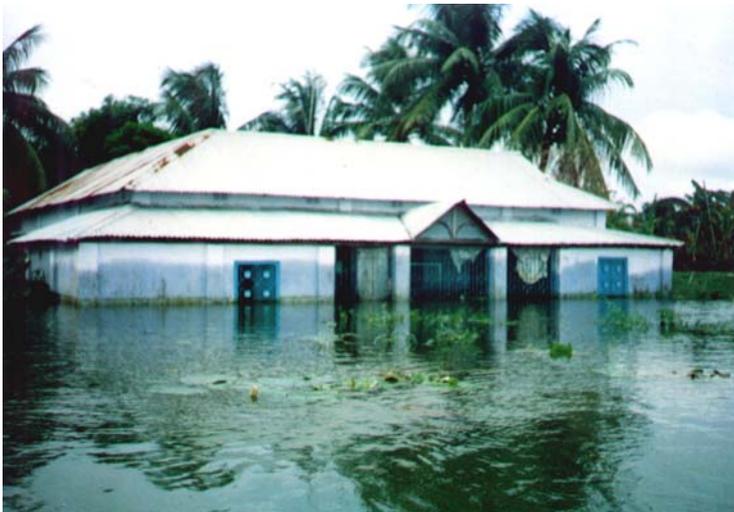
Figure 4: A pacca house under flood water

This brick boundary of the plinth starts from a certain depth below the ground level and extends up to the floor level. *Pacca* is the type of house in which the building materials are steel rod, cement, sand, brick chips, bricks, G. I. sheet etc. The structure is built as RCC structure except the roof is made of G. I. Sheet. Again, *Chhawn* house is a type of *Kancha* house with the only difference that the roof is made of grass sticks (matured, dried rice, wheat trees etc.) instead of G. I. Sheet. The overall condition of the *Chhawn* house is, in general, not so good. It is made by the lowest income people just to take shelter. The full portion of this house is made of Catkin sticks including with bamboo sticks (sometimes, the roof may be made of G. I. Sheet). No established *Vitte* has been found for this type of house.

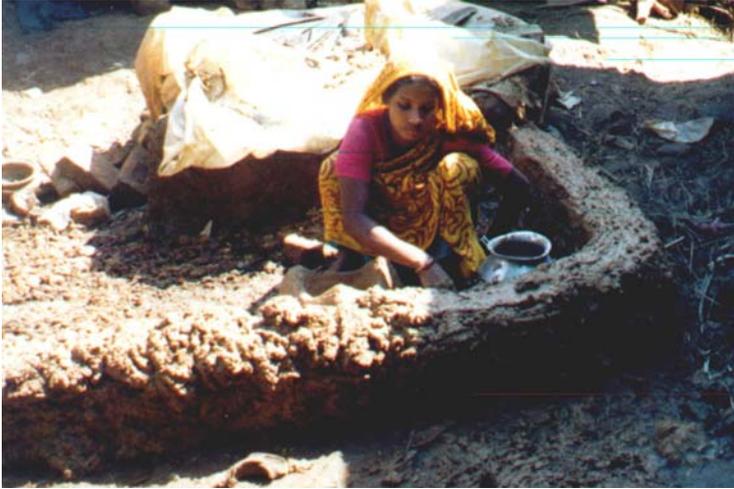
Figure 9: Rebuilding of *Vitte* washed away by flood

Villagers usually use no special technique to build their houses. In making the *Vitte* of the house, most of them use only soil by filling it up to the desired height. The desired height of *Vitte* depends on the ground level of the area. On an average, height of *Vitte* is 3.36 feet. Some people plant trees around the *Vitte* as a preventive measure against natural forces. In making the *Vitte*, villagers use water to mix with soil, so that the filled soil can be compacted well. No other materials such as rice husk, rice husk ash etc. are generally used by them. They basically do not take any special care for protecting *Vitte* from flood damage. During reconstruction of *Vitte*, house builders first put a perimeter mud wall around the proposed *Vitte*, then put soil inside and compact it (Figure 9). Lateral support using bamboo and trees are sometimes used (Figure 10). Usually people do not take any measures for protecting *Bera* from damage. Only a small percentage of people use plastic, tar for this purpose (Figure 11). For strengthening the pole of the house, pole of cement is used by some solvent people. It has been gathered that about 19% people uses bamboo for giving lateral support to *Vitte*, 39% plants trees around *Vitte* and the rest 42% take no

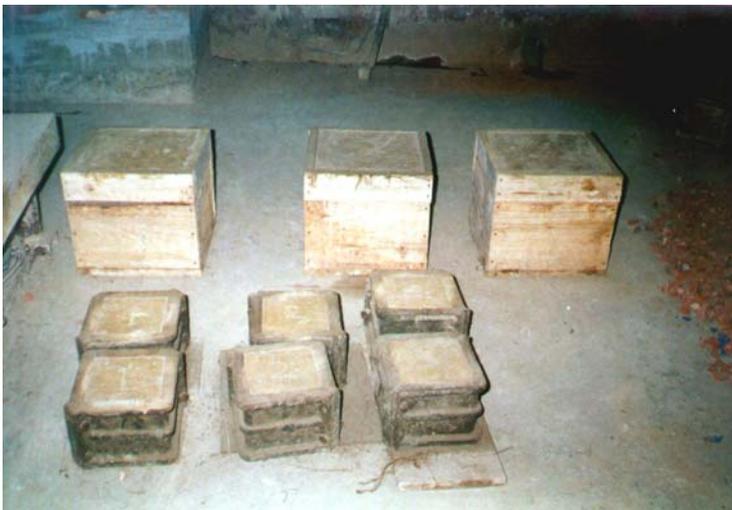
Figure 14: Mud-cement block preparation

In this regard, some recent works of Roy, et al. (2000) and Saha (2002) can be effectively used to minimize losses due to floodwater, which usually washes away the mud-plinth (*Vitte*) or mud-wall resulting in the total collapse of the poorly built rural houses. From these works it has been observed, quite conclusively, that by mixing 4%-6% cement by weight, depending upon soil type, with the soil of plinth towards the later stages of *Vitte* construction, mud-plinth can be made floodwater resistant. Figures 14 and 15 show mud-cement block casting and testing under submerged water, respectively.
