ORISSA (INDIA) SUPER - CYCLONE: IMPACT AND EMERGENCY MANAGEMENT

V K Sharma & A A Khan, National Centre for
Disaster Management, India

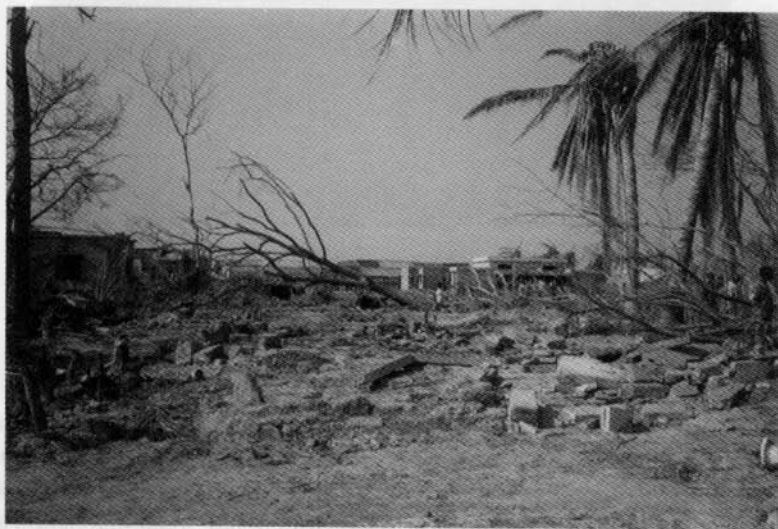
Figure 2 : The houses built by thatch etc. were washed away by the high winds and sea surges. There are no traces left of those houses after the cyclone.

3. The majority of losses due to the cyclone are to the built environment. The rural houses in coastal Orissa are non-engineered buildings. These buildings are built up with temporary materials like thatch, bamboo and mud. This type of construction is highly prone to damages in the cyclonic storms. The only way to minimize the damage is through constructing the houses with permanent building materials according to the building codes.

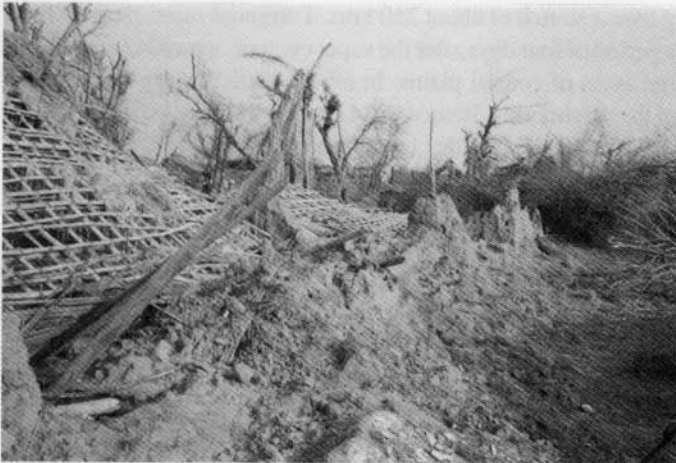
Figure 3 : Performance of houses of mud, thatch and bamboo is quite poor during the cyclone. These houses were damaged very severely during the recent cyclone.

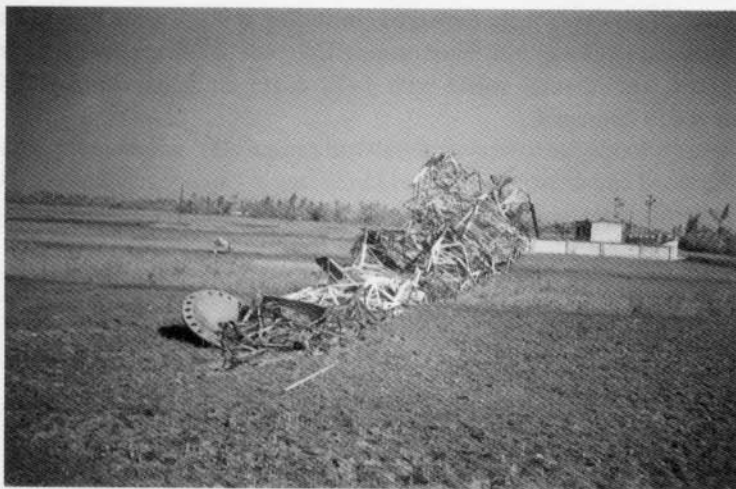
Figure 4 : The traditional modes of communication like radio, television, etc. were hugely damaged due to this cyclone. The transmission tower of the Cuttack radio station fell down on November 29, 2000 disrupting the broadcast of the warning messages

2. Communication system is the major causality in case of a cyclone. All means of communication like telecommunications, surface communication, radio and television transmission, etc. got affected due to this cyclone. The fallen trees on the roads blocked the roads and other communication means like telephones went out of order. Cyclone preparedness is the only key to overcome these difficulties. Teams should be ready to clean the fallen trees and unconventional means of communication like Ham radio, satellite phone etc. must be installed at pre- cyclone stage itself.

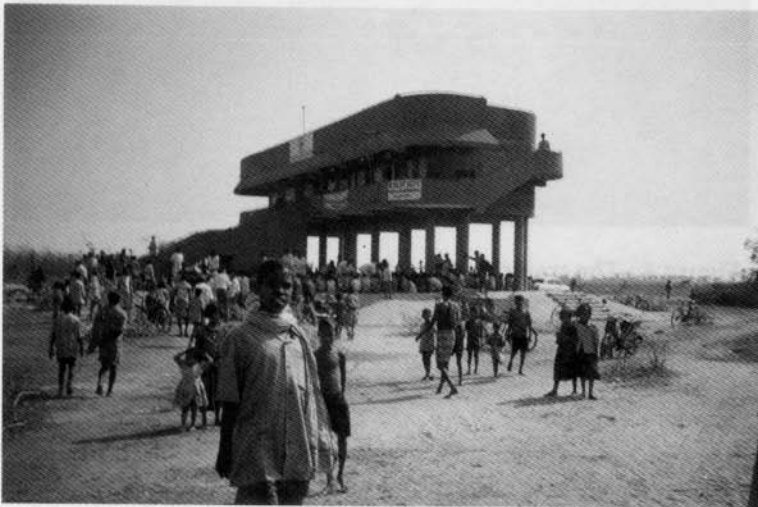
Figure 5 : Cyclone shelters built by the Indian Red Cross Society helped in saving thousands of human lives. These shelters were used very effectively as the relief centers.

4. Another way is to safeguard the people against the cyclones by evacuating them to the specially designed and constructed cyclone shelters. At present, there are twenty-three cyclone shelters in the coastal districts of Orissa. These shelters save thousands of lives in this cyclone. There is a need to construct more such shelters.

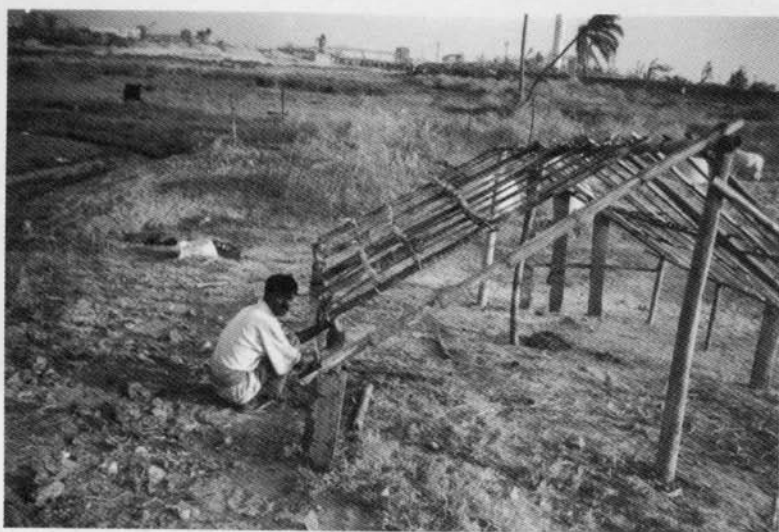
Figure 6 : People affected by the cyclone started construction of their houses again. Mud, thatch and bamboo constitute the primary building materials in the cyclone-affected areas.

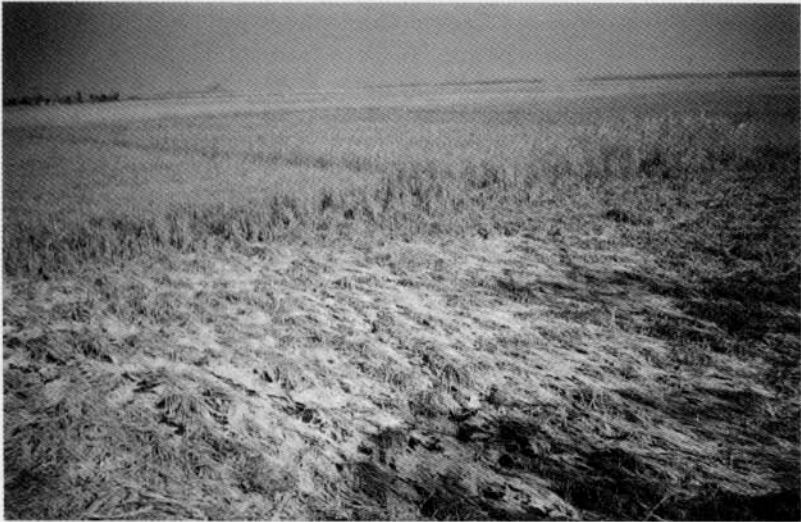
Figure 7 : Saline sea water inundated the agricultural fields causing huge losses to the standing crops like Paddy etc.

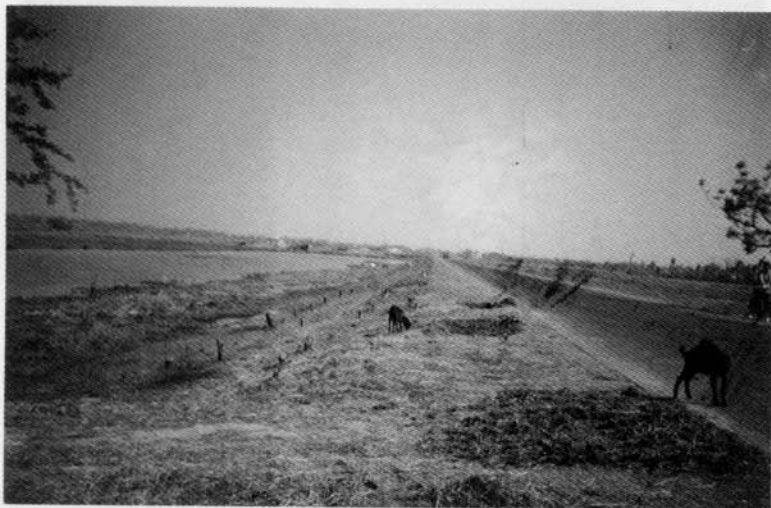
Figure 8 : A great loss to the green cover of the area took place due to this cyclone. There are no trees left over the long stretches along the roadsides in the cyclone affected areas.

5. Land use planning in coastal areas is very important and effective means of loss reduction. The human settlements and industries should not come very near to the coastline. The coastal belt upto 2-5 km. from the sea must be reserved for plantation. Low-density settlements without heavy industries may be permitted at a distance of more than 5 km. from the sea. Due to various pressures, the people have reached very near to the coastline in Orissa for settlement development and economic activities. This trend must be checked to avoid the mega disaster like this one. Mixed vegetation should be planted to act as the wind barriers to the settlements must be developed in the coastal areas.
