Impact of the 1998 Flood on the Morphology of Rivers around Bridges

**M. Mozzammel Hoque, Sujit K. Bala, Syed Mohib Uddin Ahmed,
M. Anisul Haque and Saifullah Al Mamun**

Institute of Water and Flood Management

Abstract

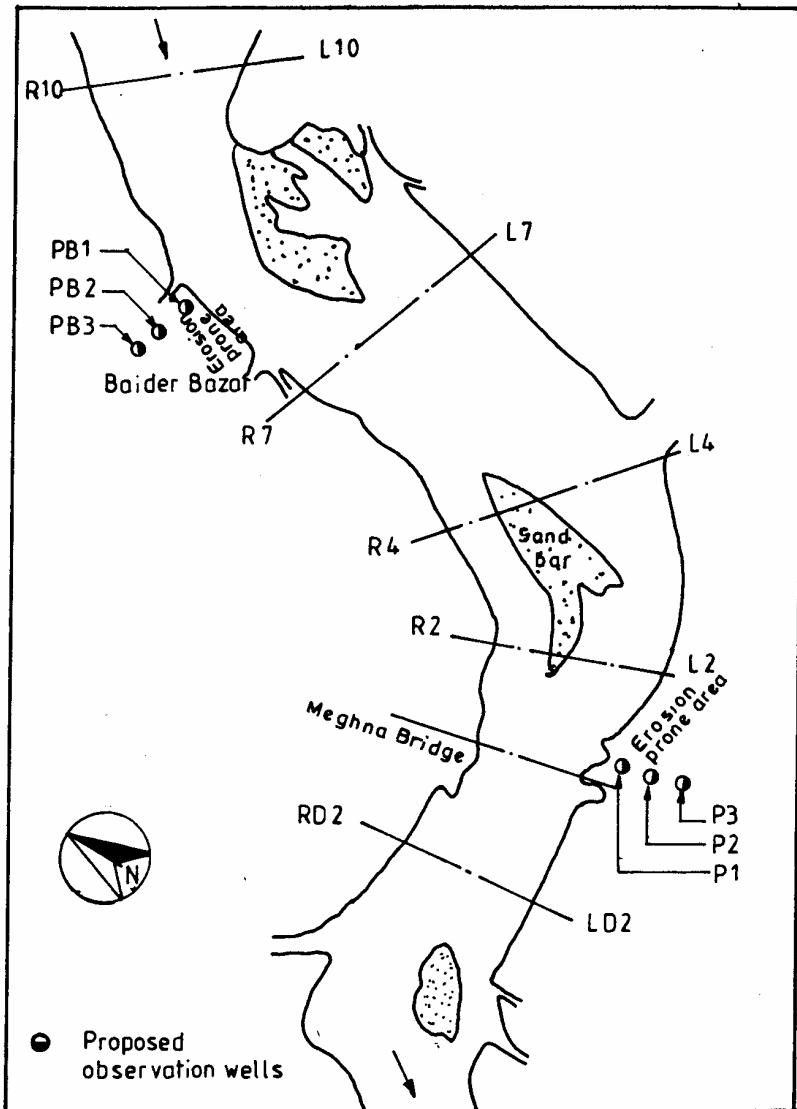
Figure 2: Location map of the study area

To evaluate the morphological changes at the vicinity of the bridge, a river reach of about 1km downstream of the bridge and 5km upstream has been considered. This reach has been studied by Japan Bangladesh Joint Study Project on Floods (Hoque et al., 1997). The selected river reach is shown in Fig. 2.
