Potential hazards and vulnerability in urban development of Dhaka city, Bangladesh

Salek M. Seraj & Abu B. M. Badruzzaman

Bangladesh University of Engineering and Technology, Dhaka, Bangladesh

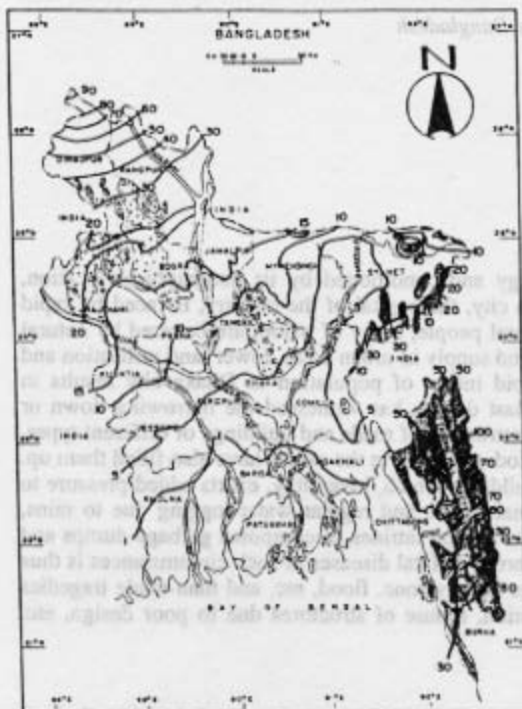
Figure 1 Map showing major geomorphological zones and generalized contour map of Bangladesh

and recent) sediments deposited by the Ganges-Padma, the Brahmaputra-Jamuna, and the Meghna river systems and their numerous tributaries and distributaries. Figure 1 shows generalized contour and major geomorphological zones of Bangladesh. Whereas half of the country lies within an elevation of 10 meters above the mean sea level, the elevation of its capital Dhaka is only 5 meters above the mean sea level. Floods in Bangladesh are mainly caused by heavy rainfalls during monsoons and sometimes by excessive flow of water from the upper riverine countries such as India and Nepal. Excessive rainfalls flood the low lands and submerge all settlements in these areas. Understandably, Dhaka city is affected by floods time to time.

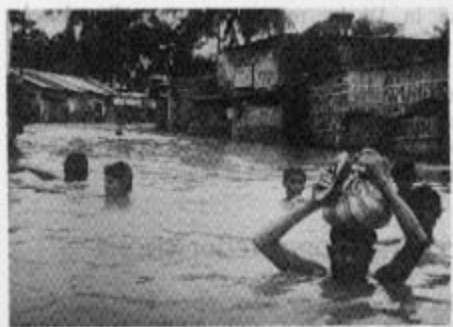
Figure 2 Extent of flooding in a poor neighbourhood of Dhaka city in 1988

Dhaka city population was directly affected by these floods. Figure 2 shows the level of flooding in a poor neighborhood of Dhaka city in 1988.

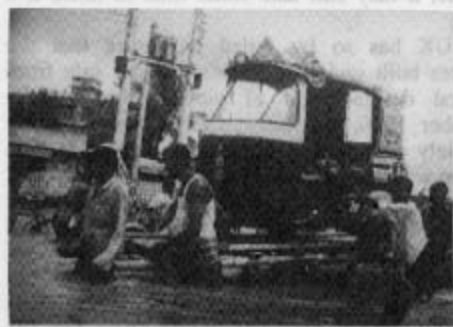
Figure 3 A water-logged Dhaka city road

in such circumstances. The grave condition that prevails in Dhaka city roads can be visualised from Figure 3 where a push-cart can be seen transporting a three-wheeler.

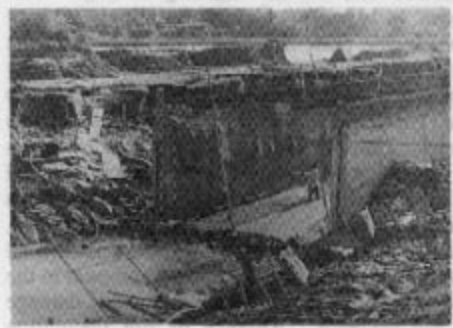
Figure 4 Storm sewer construction while earth filling surrounding natural drainage channel

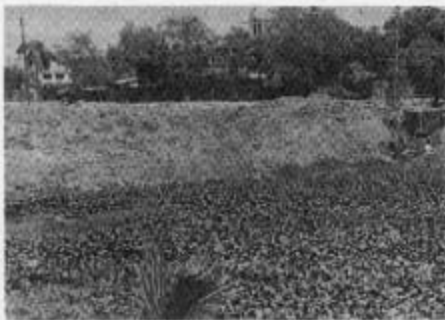
Figure 5 Land filling in Banani-Gulshan lake

Banani-Gulshan lake, located in a residential area where the very rich and the very poor slum dwellers coexist (Figure 6), receive primarily domestic sewage without any treatment and surface runoff. The situation is complicated by the fact that part of the lake was reclaimed through landfilling using solid wastes from various sources. No precautionary measures have been taken to divert the leachate generated from the decomposition of organic wastes and no lining has been provided. Thus, leachate from the landfill area goes directly into the lake water. In August 1996, episode of widespread fish kill have been recorded by the Department of Health. However, no study has been conducted to identify the cause of this fish kill episode.

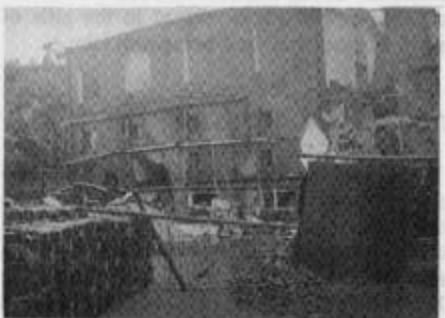
Figure 7 A seven storied building after collapse

RAJUK has so far failed to ensure that the structures built under its jurisdiction are safe from structural design point of view. Recently, in September 1996, a seven-storied framed structure completely collapsed at Kalabagan (Figure 7). The structure was badly designed and poorly constructed. In order to ensure safety of life, old and potentially dangerous dilapidated buildings should be identified and demolished, if economic renovations are not possible.
